## APPLICATION NOTE

## **Delta Series, DPA Series**

How to use the "PIC" programmer to update the front panel firmware.

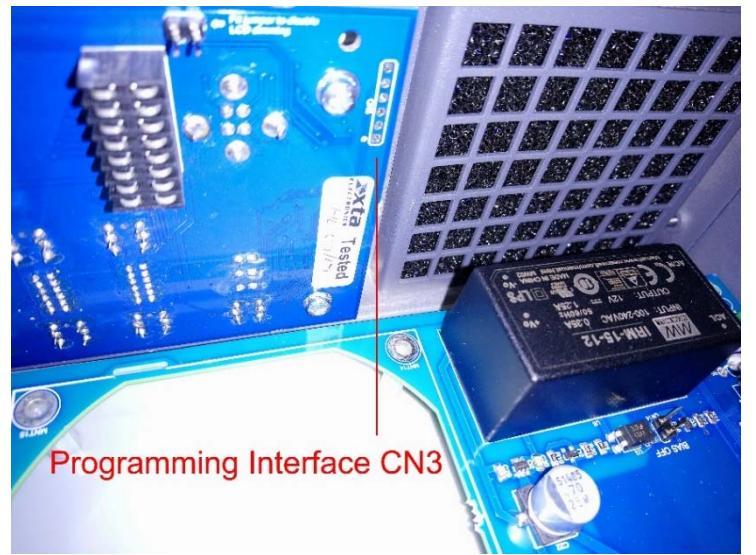
The header (programming interface) is a column of 6 blank holes on the rear of the front panel circuit bard, labelled CN3. This is located on the extreme right of the amplifier (with the front panel facing away from you). Photos shown are of Delta amplifier circuit boards – DPA amplifiers and OEM derivatives are broadly the same except for the orientation of CN3 – it is located horizontally on these amplifiers.

The lowest hole (one nearest the bottom, by the tested sticker) is marked with a dot – this is pin 1.

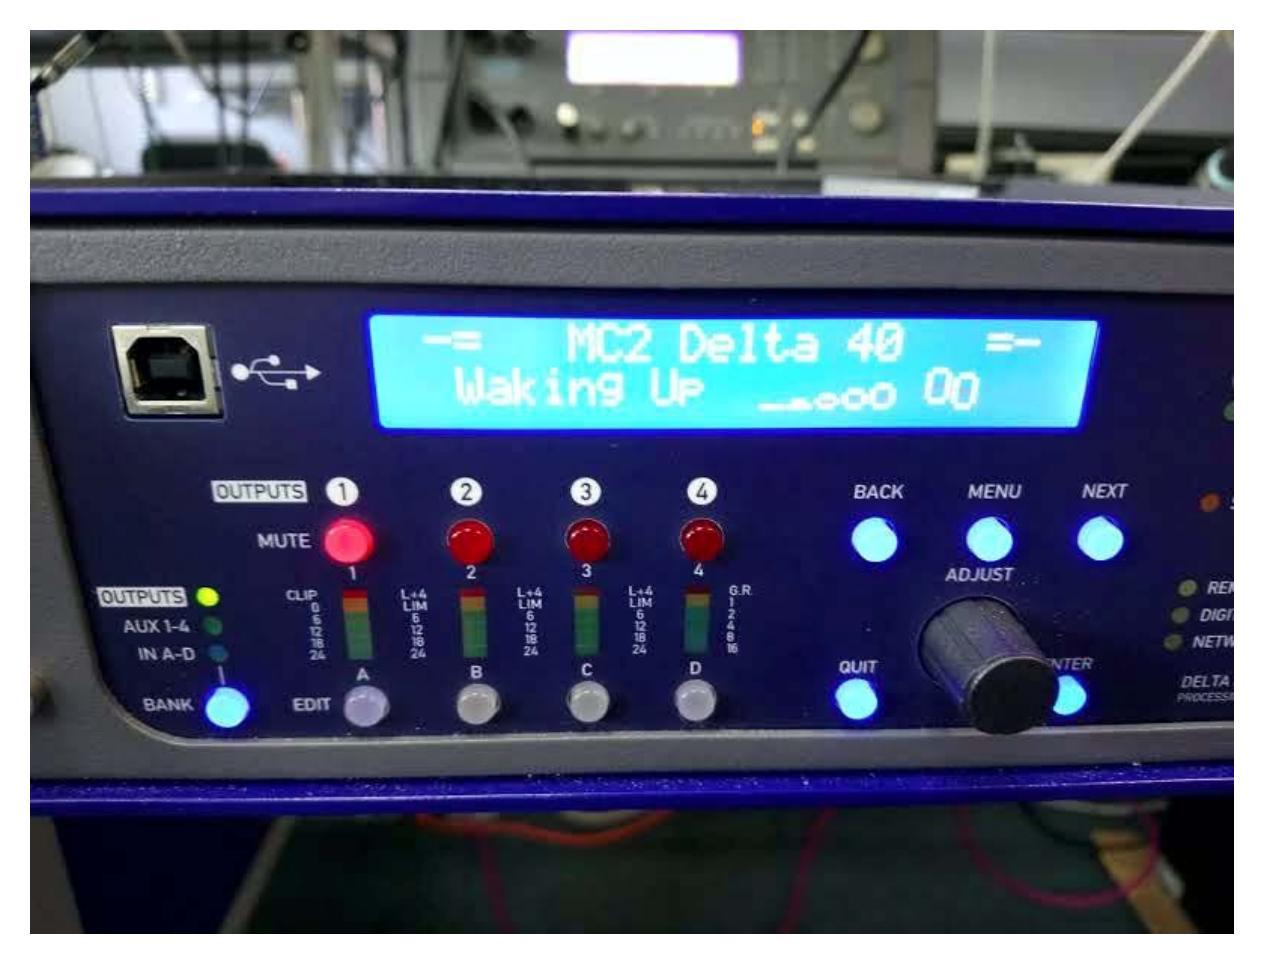
The main firmware in the amplifier will also have to be updated if it is before version 1.27. The amplifier will function with older firmware, but the LCD operation will be compromised. If the display shows something similar to that shown below during the wake-up phase, a firmware update will be required.

Loading new firmware or presets uses the same "Flash Loader" utility that is bundled with the firmware or presets "bin" (binary) file. Firmware (or Program) files have the prefix "LTAM", and preset files have the prefix "LTAR".
